Material Re-use Case Study:

1. Overview: Genesis of project

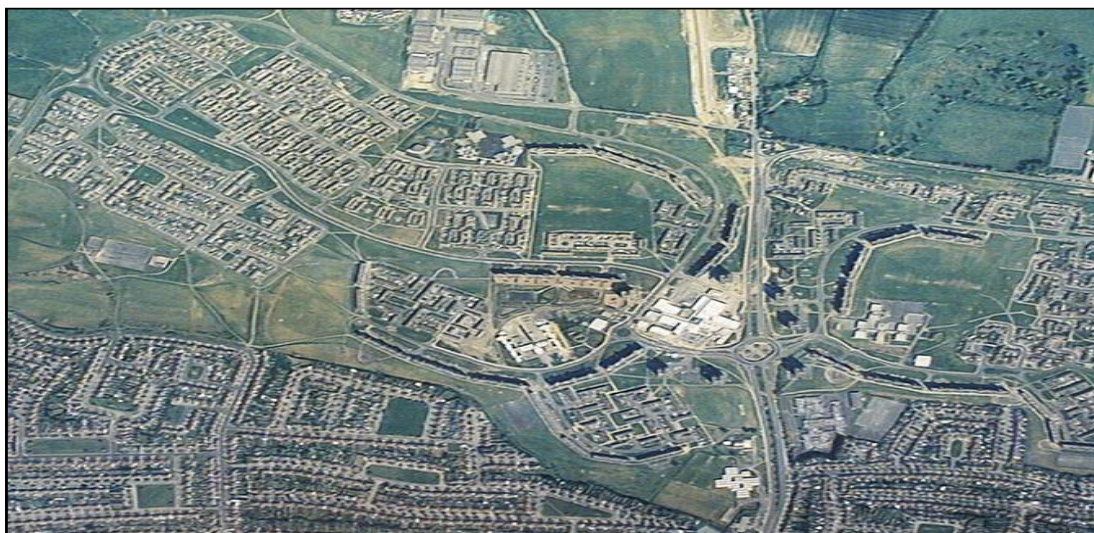
Ballymun was developed as a mass-produced, high-rise, low-density social housing development in the 1960's to alleviate overcrowding in Dublin's inner-city tenements. 3000 apartments were constructed from pre-cast concrete which were produced in a factory based on site in Ballymun. The slab blocks were arranged in long spines radiating from the town centre. 15 storey blocks formed a central ring, with 8 and 4 storey blocks radiating out from the centre.

Figure 1 - Aerial view of Ballymun before the Regeneration

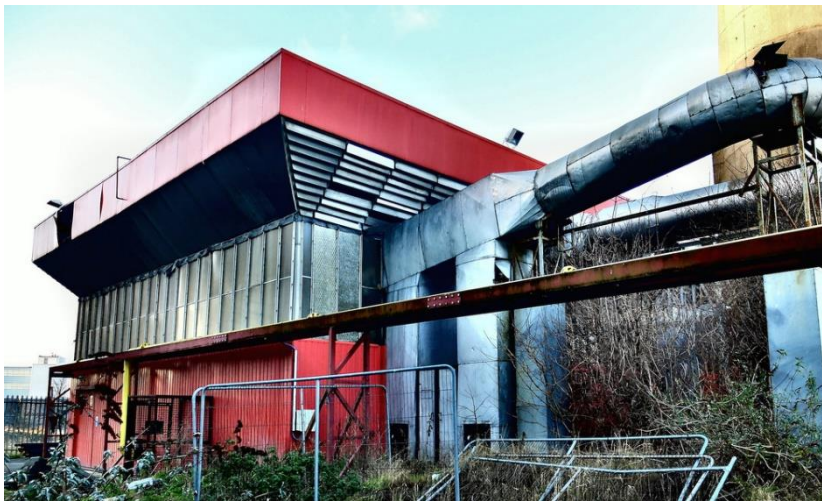
Figure 3- The old Ballymun Boiler House (2012)

The historic Boiler house, which is the subject of this study, sits in parallel with the development and regeneration of Ballymun. Initially in the 60's the Boiler House was developed to house the district heating system which serviced the new slab blocks. 3000 homes were all supplied with underfloor heating and hot and cold water from the centralised boiler house situated on main street. The Boiler house site included a reservoir for mains cold water supply, oil tanks and an 80m chimney stack.

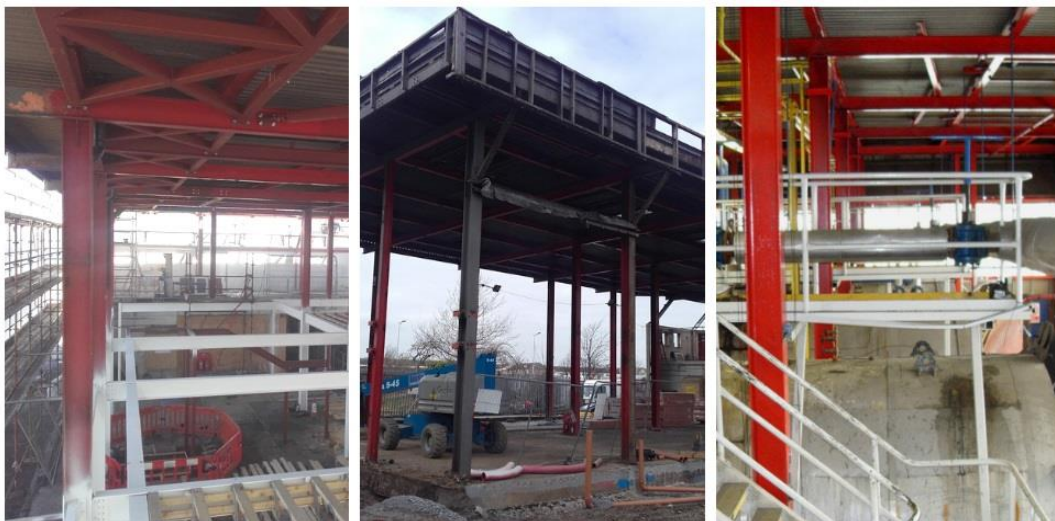
Structural Frame

The structural frame was able to be re-used. It was in good condition and there were no areas of rust and deterioration of the frame. However, the steel frame did not comply with current structural standards and additional structural members would be required to stiffen the overall frame.

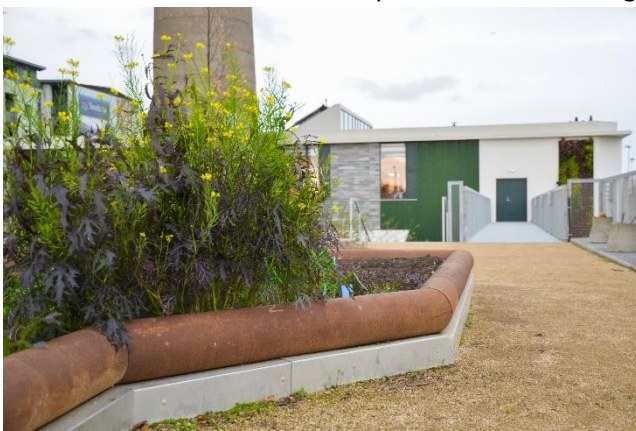
Figure 6 - Kitchen Garden relocated to the Reservoir roof.

reservoir but in general this did not affect the functionality of the building, the outdoor classroom or the demonstration capability of the overall project. On one side of the reservoir additional structural support was required to accommodate the extra weight of a kitchen garden which was relocated to the reservoir roof following the reconfiguration.

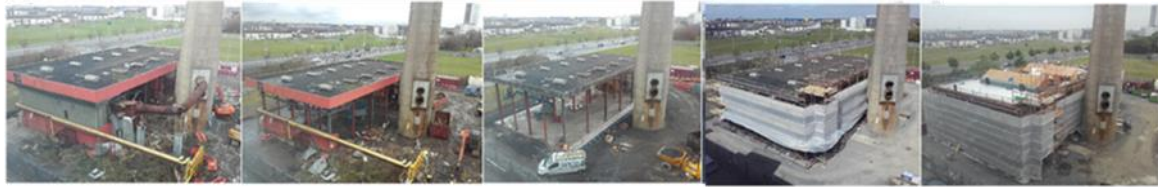
Figure 8 - Building progression

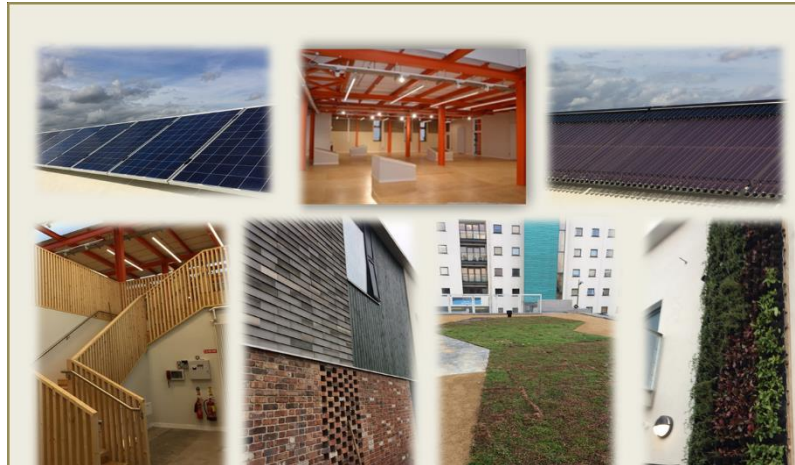
In addition to the brickwork timber cladding was used at a higher level. We were not able to find any re-used timber cladding that could be used on the building. This was due to poor quality of material, re-finishing costs, lack of availability, limited quantity and concerns about longevity of material. Therefore, thermo-treated FSC timber was selected with a stained finish.

Figure 10 - Building Finishes

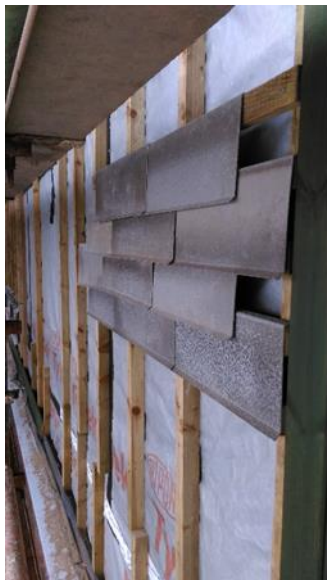
Figure 11 Reused aluminium for external wall cladding

The aluminium fins salvaged from the original building were also used as cladding in a certain area of the wall. This produced a very interesting external finish and again demonstrated innovative re-use in building design as shown in Figure 11.

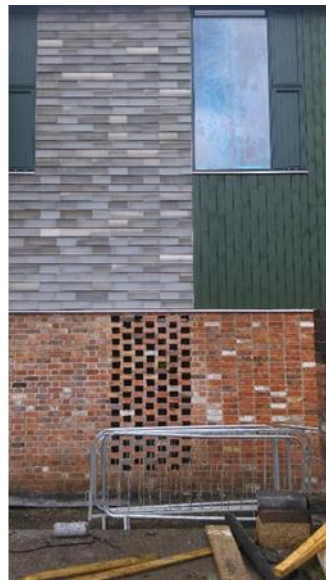
To the north of the building there was an existing cavity wall. It was decided to externally insulate this wall with wood fibre insulation. This insulation is made for a sustainable timber resource and it also has the opportunity of demonstrating an energy conscious retrofit process from a public awareness point of view.

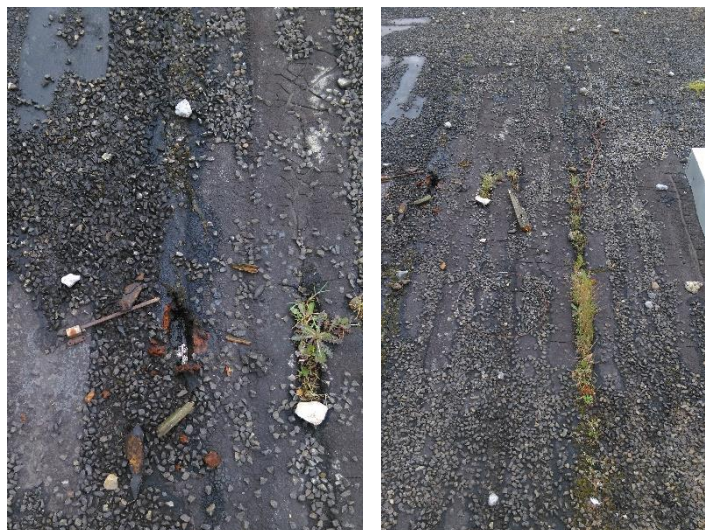
Figure 12 - Damaged roof board

The board was saturated and badly damaged. If the existing roof was to be retained as proposed there would be no way to release the trapped moisture. It was decided to remove the existing roof.

- Roof: When the roof was inspected on site it was decided that it was not able to be used. There was a board used as a deck below the waterproof finish and this was completely saturated. This roof was stripped and replaced with a new membrane in order not to trap moisture inside the building.
- Roof insulation: A foam glass insulation was specified for the roof. This is a non-petrochemical based insulant. However, post tender this was omitted for conventional insulation to save money to bring the project back within budget. We tried to find alternative re-used insulation, but this was not available in the right quantity for the project and new insulation was used on site.

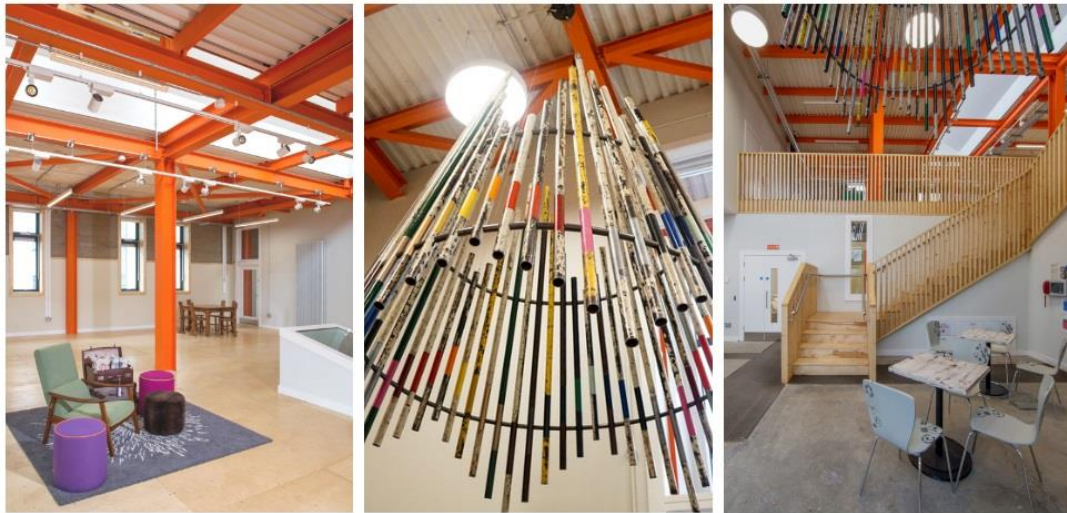
As mentioned previously, the Hempcrete walls were presented as the internal finish on the upper levels of the inside face of the external walls. At low level, where the wall can be touched, it was finished with a lime plaster. This produced a robust internal finish but revealed the make-up of the wall at a higher level. Again, this met the requirements of the original design intent.
